# Preventing Hook-a-likes

**JAMES ABBOTT** reports on Network Rail Southern Region's landslide avoidance strategy

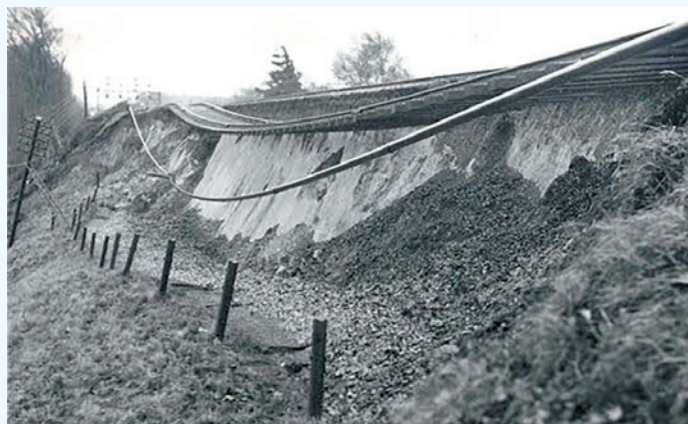
It's happened before: landslide at Hook in 1960. Courtesy Network Rail

that took place on the other side of the line near here in 1960.

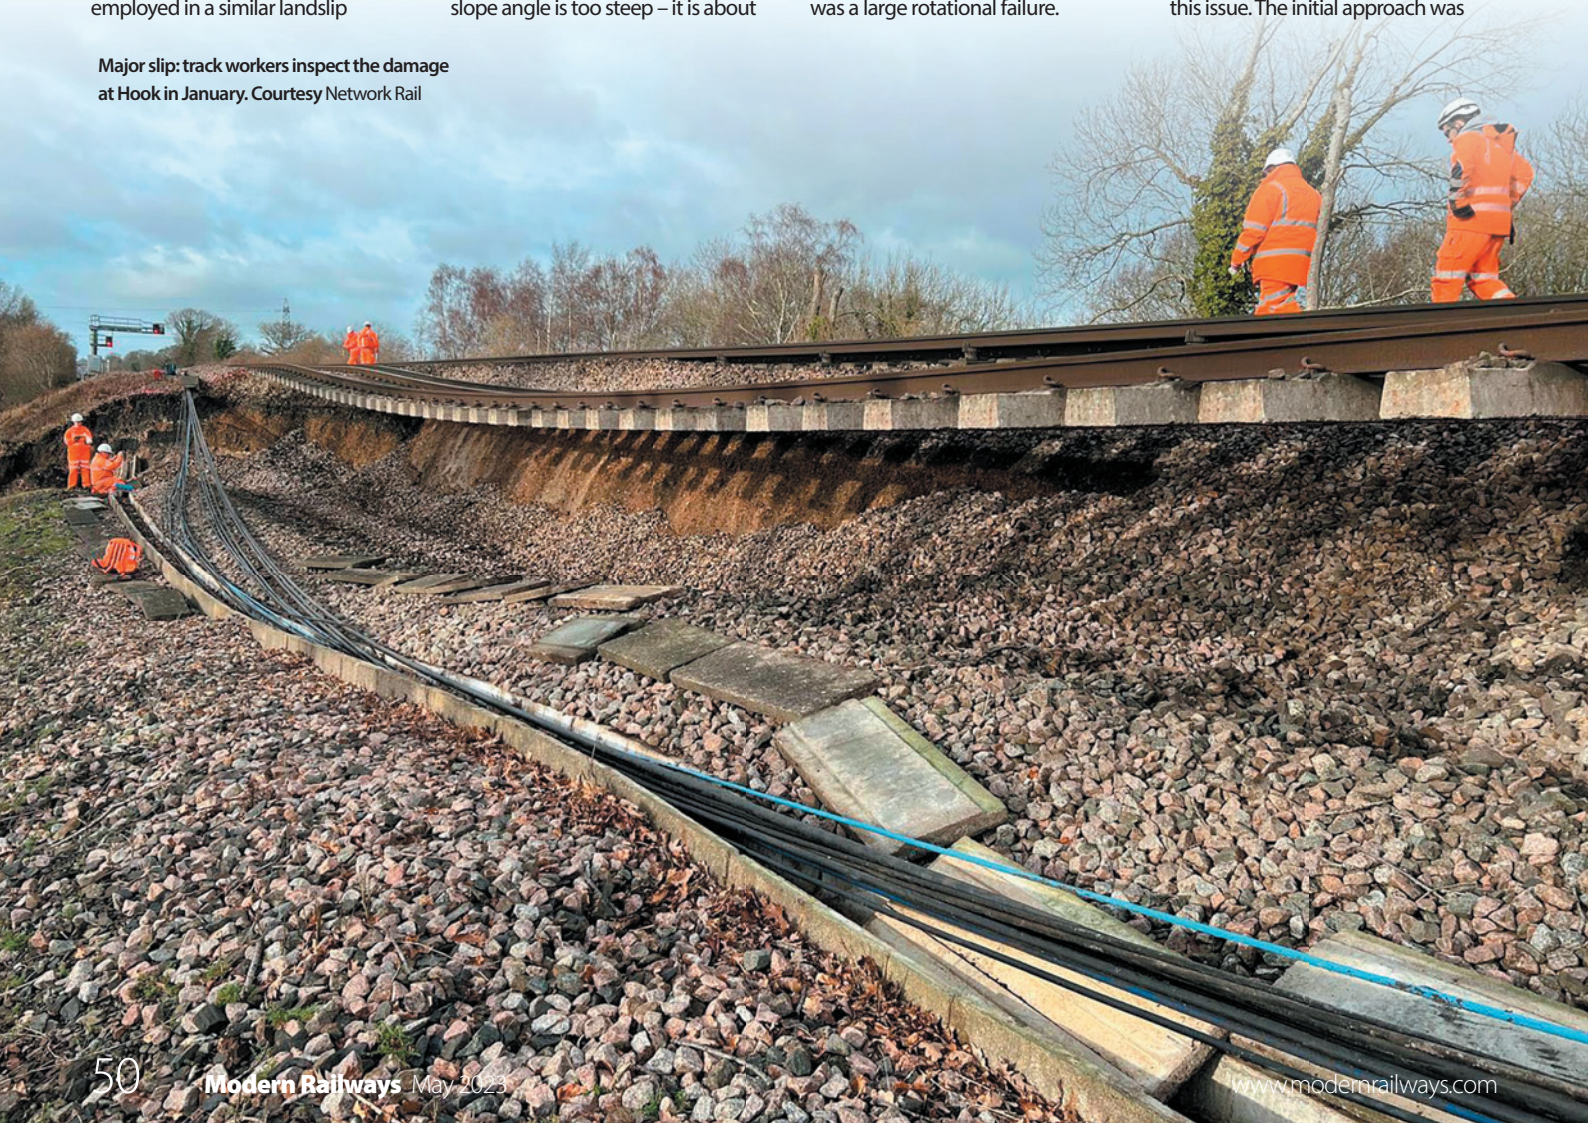
Major slip: track workers inspect the damage at Hook in January. Courtesy Network Rail

This is plainly an unstable stretch of line, leading NR to look more closely into the nature of the structure. 'The Victorians didn't know that if you put London clay over alluvium, which is what we have here, you create an unstable structure' says Mr Butcher. 'That's compounded as the slope angle is too steep – it is about

double the steepness that would be set by modern design standards. On top of that we had five months' worth of rain in three months, so it was all very wet.' Drainage issues had already been reported at the toe of the embankment in exams, and the drains were potentially not functioning at full capacity. The result of all this was a large rotational failure.

The remedy was to insert a sheet pile 60 metres in length at the bottom of the embankment, joining up with an earlier repair dating from 2010. 'This embankment has been fixed previously, so it clearly has history.'

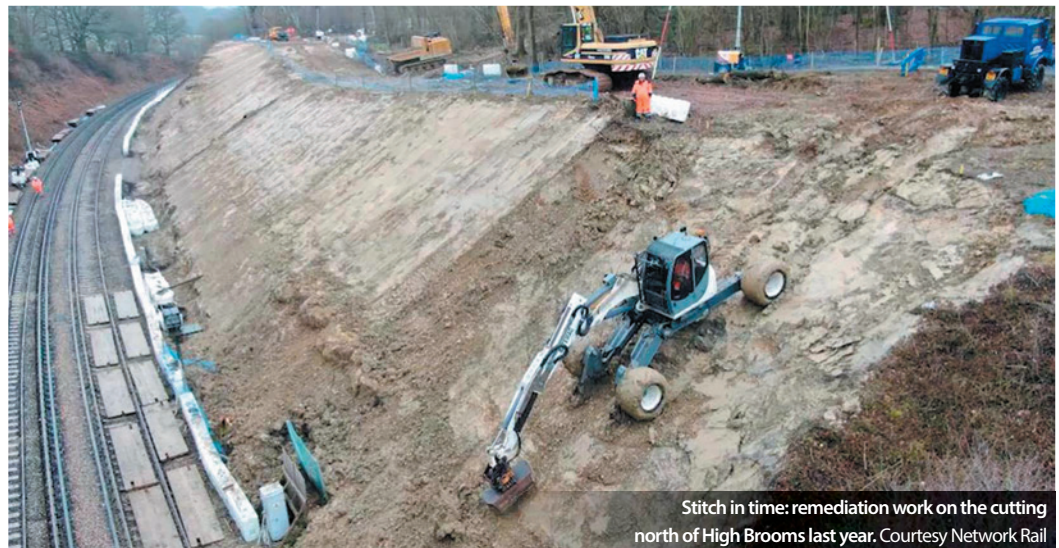
Stitch in time: remediation work on the cutting north of High Brooms last year. Courtesy Network Rail

Further proof of the value of the system was provided when it prompted emergency repairs to a cutting north of High Brooms on the Hastings line last year, while in January this year the remote condition monitoring gave advance warning of another potential cutting failure on Wessex Route. 'It is helping us to predict and prevent trouble in future' says Mr Butcher.

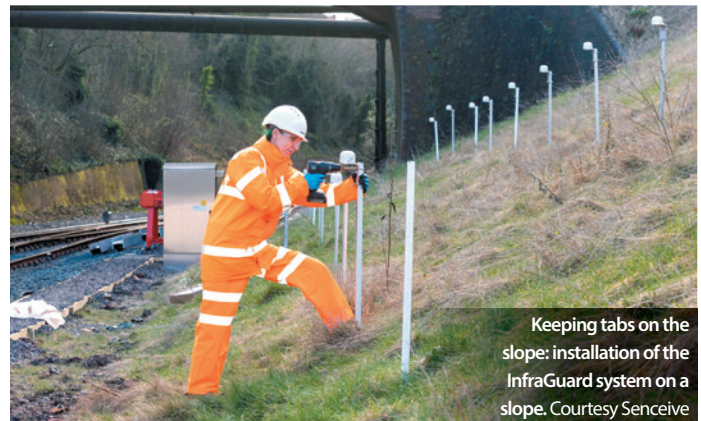
Keeping tabs on the slope: installation of the InfraGuard system on a slope. Courtesy Senceive

More than 17,000 nodes have been installed on earthworks on Southern: these devices detect when there is movement and send messages to a control centre. In addition, 670 cameras have been installed to complement the nodes. 'If a node sends a message saying: "I've moved", the cameras check on whether there is material that has slipped on to the track – that's much quicker than sending out a Mobile Operations Manager to check' explains Mr Butcher.

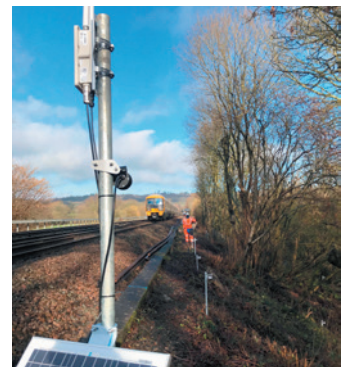
Monitoring system: the InfraGuard nodes monitor the stability of the slope, while the solar-powered camera mounted on the pole allows visual monitoring of any slippage that does occur. Courtesy Senceive
