Digging Deeper | Transportation

Bridge Fix Bolsters Lifeline as Sandy Repairs Conclude

Metropolitan Transportation Agency's \$49-million subway link and communications upgrade in Queens, N.Y., has benefited from a mild winter

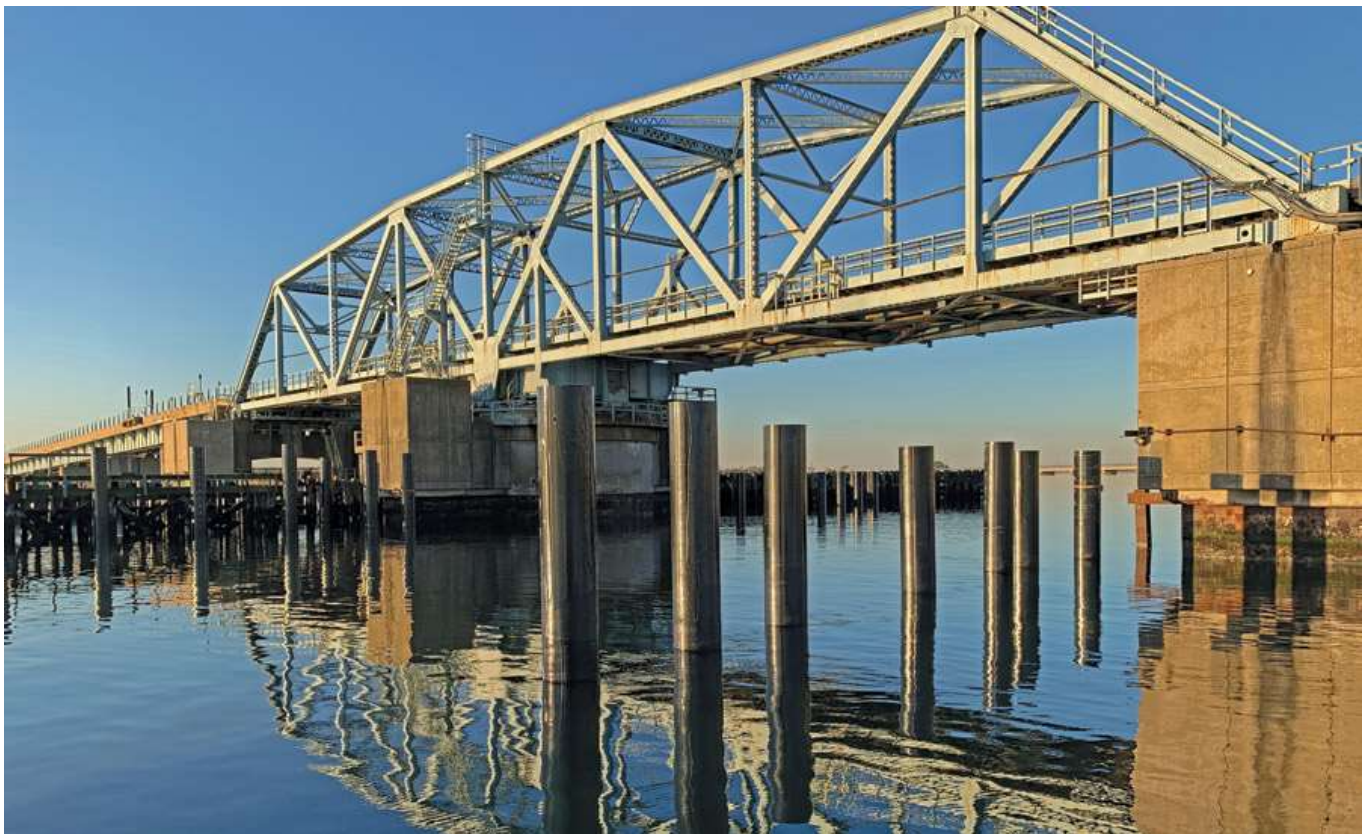
The Sandy Repairs Rockaway Line Wrap-Up includes rare vibration monitoring methods that have only been performed a few other times throughout the country.

Another key element of the project has been the extensive effort to protect the existing bridge and ensure that demolition, fender system repairs, pile-driving and other work does not damage the structure. The vibration monitoring system that Big Apple Group is using on the project involves new technology only applied on a handful of other projects in the U.S.

The wireless remote condition monitoring technology from Senceive that the team is using tracks any rotation, deflection, displacement or deformation of tracks, piers or the bridge structure. It's an improvement over traditional monitoring technology and surveying techniques, says Alex Sabetta, northeast regional supervising engineer at Big Apple Group.

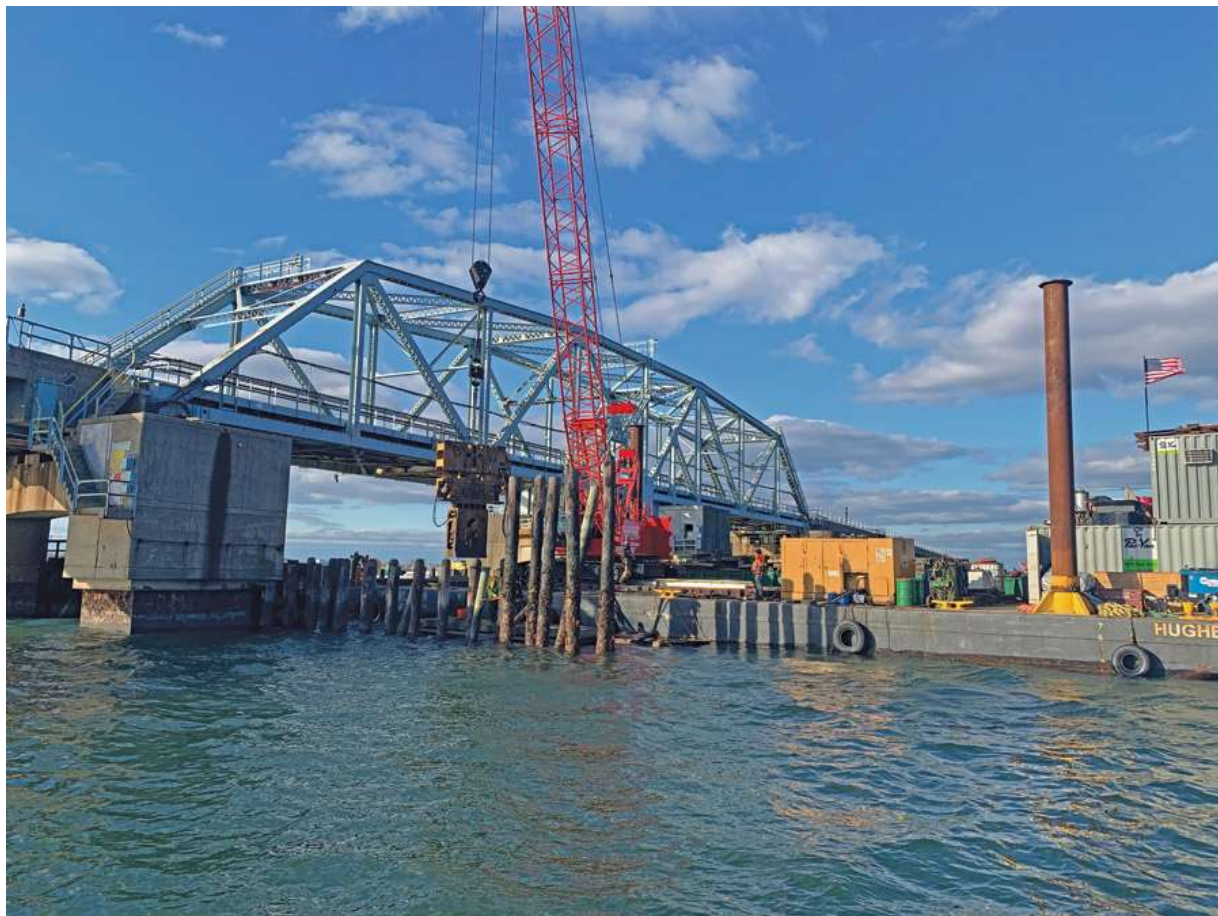
Crews remove timber piles from the bridge’s old fender system using a crawler crane operating from a barge.

“We’ve already removed the existing fenders, timber round piles and pile clusters, timber walers and lighting,” she says.

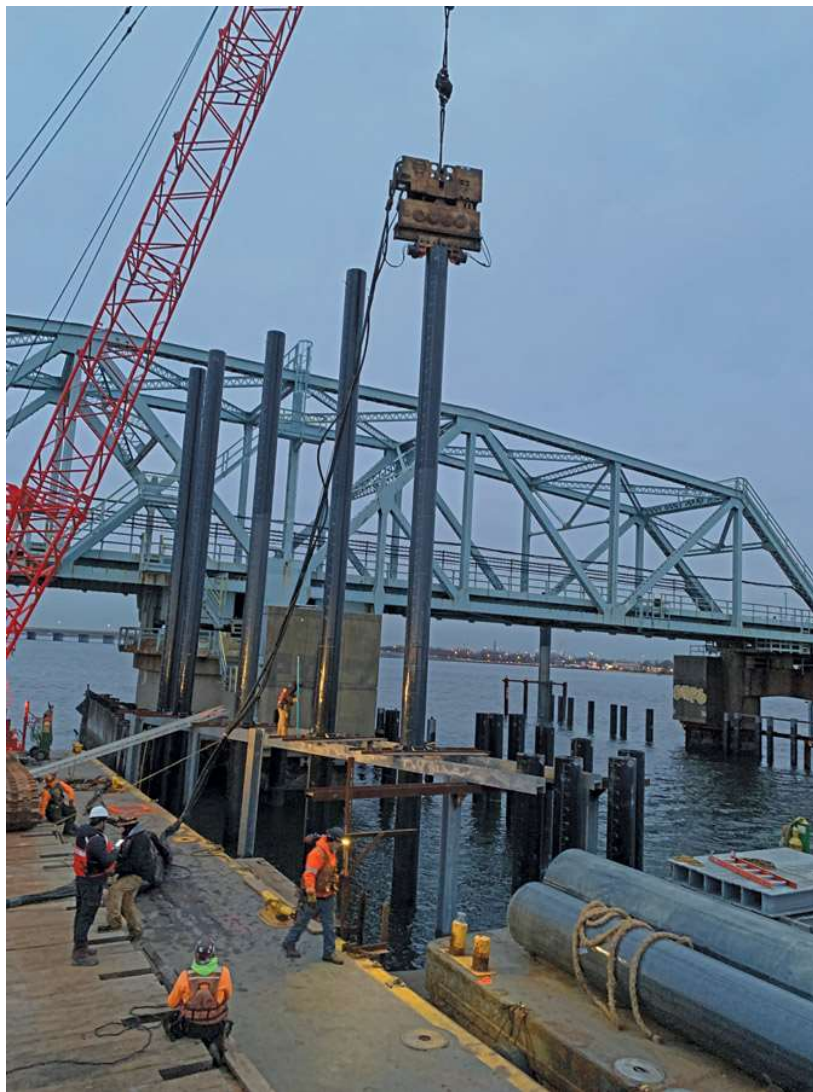
The team works on installation of fiber-reinforced polymer piles near the bridge, which later will involve adding new walers as well.

Navillus partnered with pile manufacturer Creative Composites Group in suggesting an alternate design, which HDR and MTA evaluated. It uses fewer, larger piles compared to the previous layout, with far less mudbank disturbance, Clancy says. The new design has 68 larger hollow fiber-reinforced polymer seawall piles instead of the previous 440 solid timber piles or pile clusters. That includes 60 FRP piles, each with a diameter of 24 in.,

replacing 434 13-in.-dia solid piles, along with four 36-in.-dia and four 48-in.-dia FRP dolphin piles that are standing in for eight previous 13-in.-dia solid pile clusters, she says.

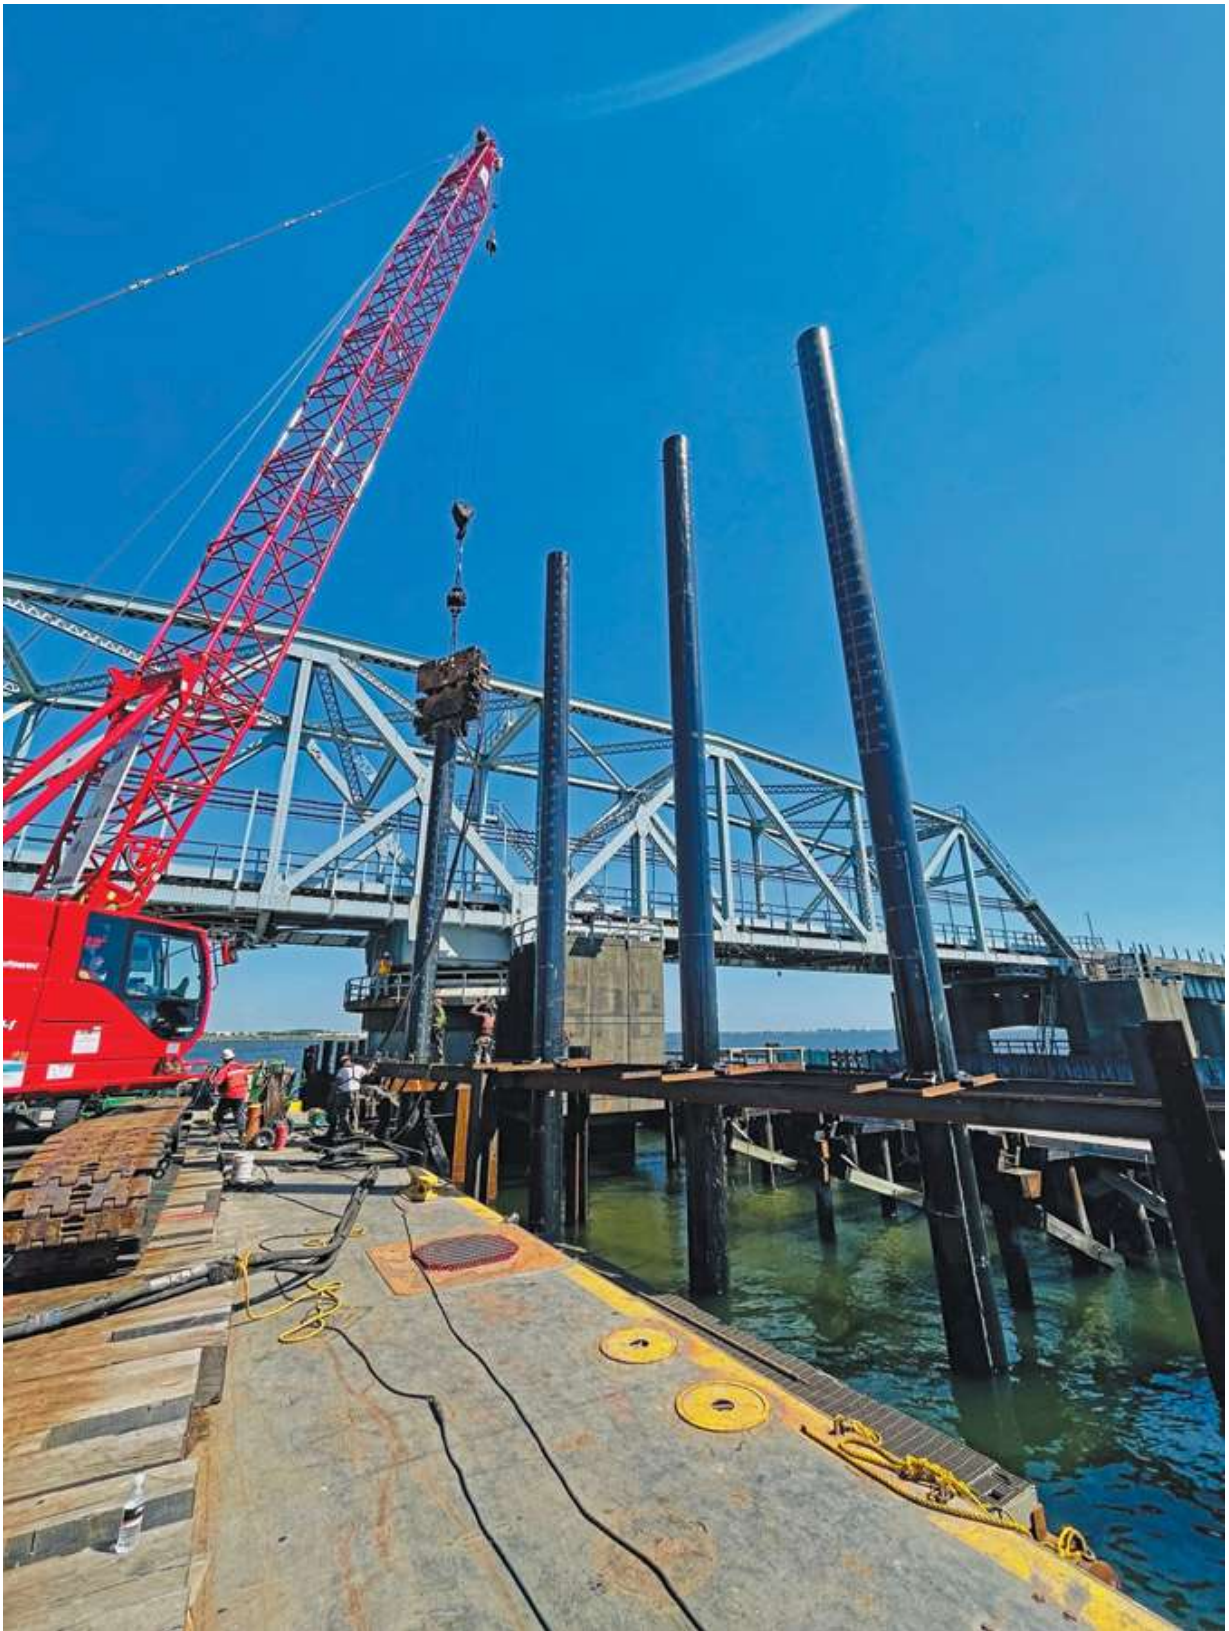
Crews operate a crawler crane from a work barge that has a vibratory hammer attachment to drive the 24-in. piles into the mud bed.

“The difference in material is important,” says Priyank Patel, project manager at Navillus. “When you’re installing a solid pile, you need a heavier hammer and there’s more vibration. A hollow pile does not disturb the mud bed as much.”

The largest pile is 94 ft long and extends 73 ft into the ground, Patel says. Installing fewer piles also has benefitted the construction effort, given the uncertainty of working from barges on the water, he adds.

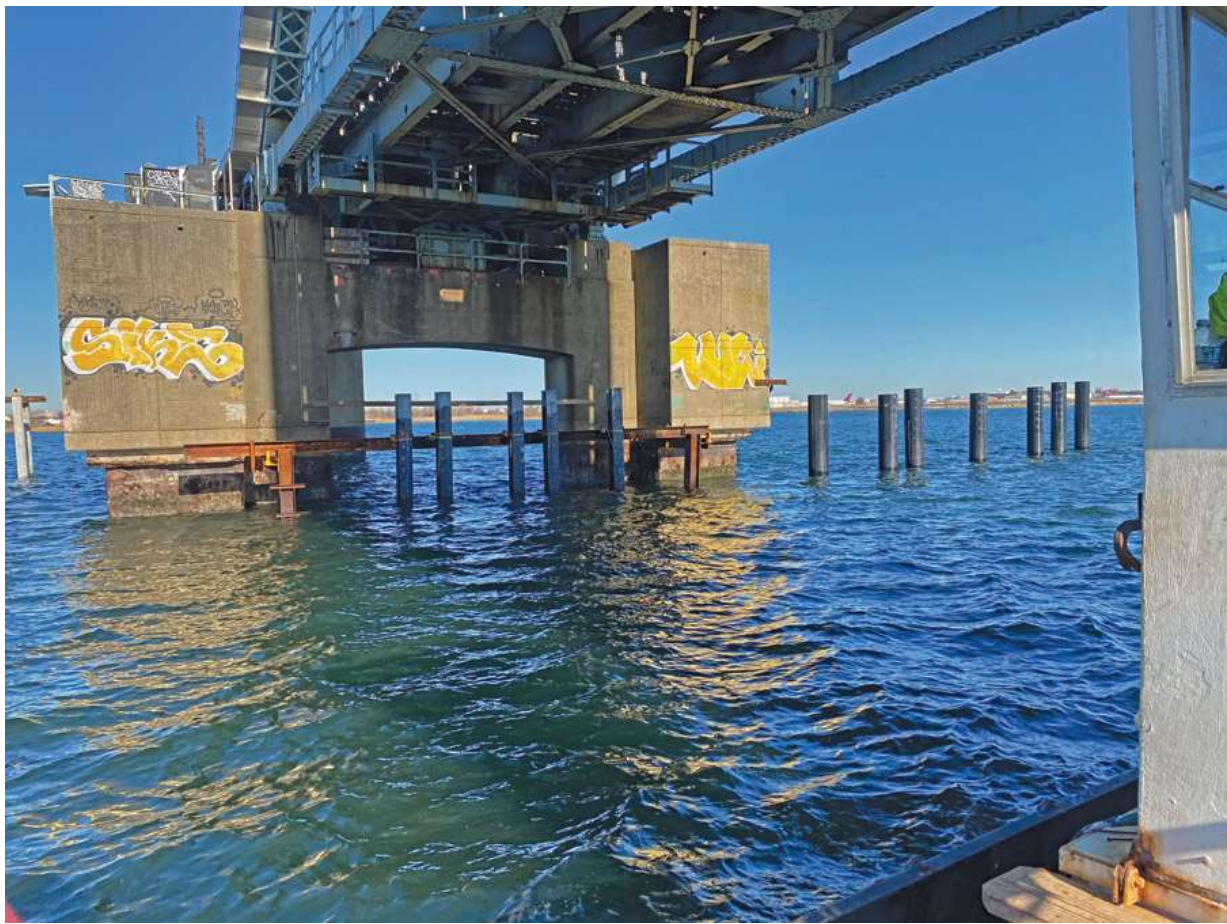
The project is using innovative wireless movement monitoring technology to ensure that demolition and construction don't damage the track or bridge structure.

The system uses two types of wireless nodes attached to track beds and piers on the bridge, all powered by long-life batteries and hooked up to two data relay stations, says Dan Miller, head of business development for the Americas at Senceive.

The system uses the MTA’s own allowable movement thresholds, with measurements down to “sub-millimeters,” Miller says.
