MOVING MUD

Dealing with weather damage around the country

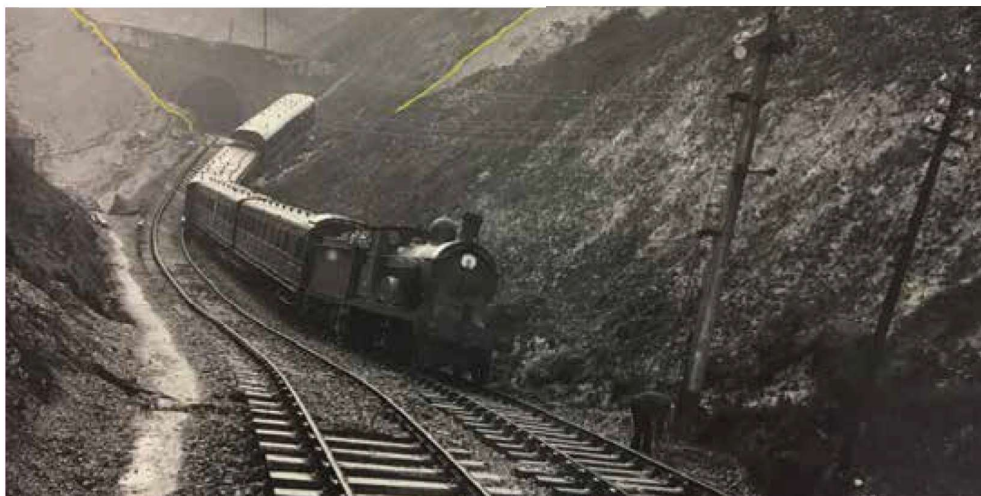
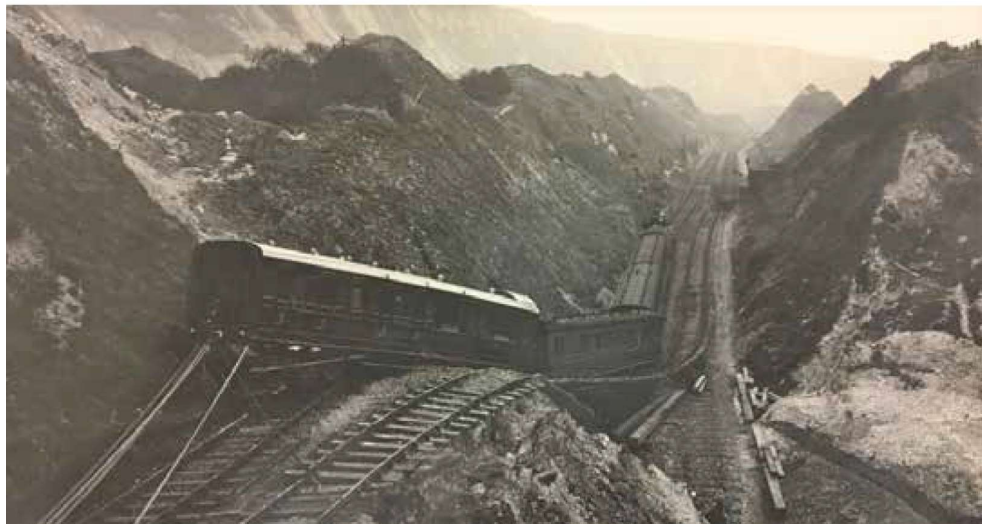
One of the worst was the 'Great Fall' of 1915 (above). This took place at Folkestone Warren in Kent. The South Eastern and Chatham railway line was moved 50 metres towards the coast as 1.5 million cubic metres of chalk fell into the sea, following weeks of heavy rain. The line was closed for almost four years, as repairs were delayed by the Great War.

Photographs of the incident show a badly affected train, but it wasn't as bad as it looks. Derek Butcher, the Network Rail route asset manager for geotechnical engineering who found the historic images in a filing cabinet while moving offices, explained: "We believe the train pictured was alerted to the landslip by the signal box at Folkestone Junction and was slowed down and found itself part on and part off the landslip. They were able to evacuate passengers who walked through the tunnel to Folkestone Junction station.

"There was a significant amount of movement following the train stopping. That's why it looks so horrific."

The kink in the line remains visible today, underscoring the severity of the incident. Landslips have been a major feature of the line since it opened in 1844. In 1877, two people died when part of the Martello Tunnel was destroyed. The line remained closed for three months afterwards.

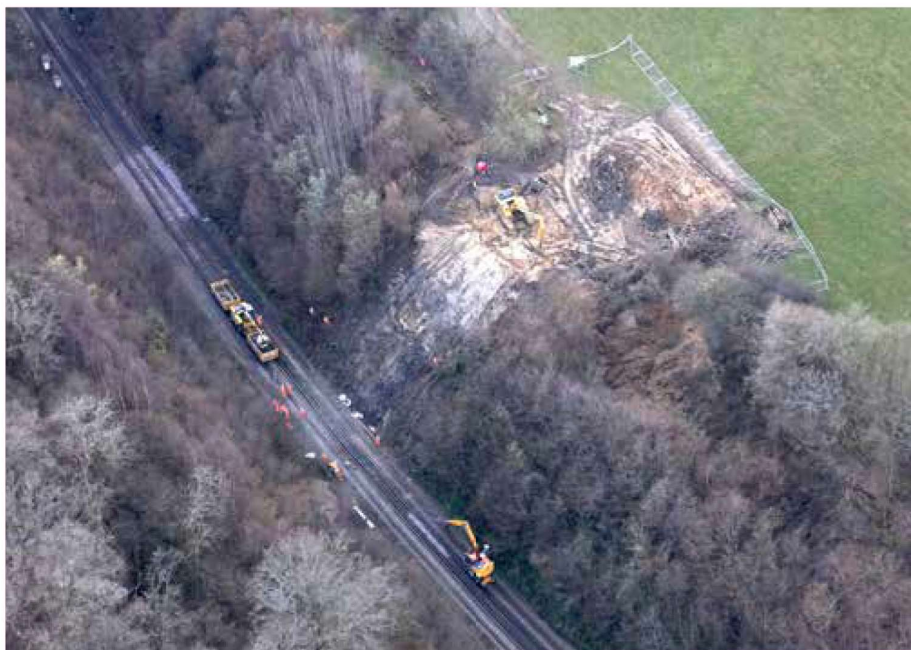
At 12:45 on Wednesday 13 March, the Tonbridge signaller reported that a train on the Charing Cross to Hastings line had struck overhanging vegetation just south of Wadhurst station (below). Damage was slight and the train was able to continue on to Charing Cross, but a Network Rail team was despatched to investigate the problem.

At first, there was nothing much to report, just some small trees overhanging the line. But, when the team started to clear the vegetation, it was noticed that the reason the trees were so close to the track was that the cutting face they were growing out of had slipped down towards the line and was still moving.

Further investigation was impossible as the moving earth, some of it in large clods measuring five metres by two metres, continued to move, making it too risky for inspectors to get on site.

Things had calmed down by 07:00 the following morning, when Derek could make an assessment. He noted that some 60 tonnes of material had slipped, possibly due to a combination of heavy rain and high winds, and this would need to be removed.

Negotiations took place with the farmer who owned the field at the top of the cutting to allow access for a 130-tonne excavator, with a 30-metre-long reach, that could drag the loose material up the cutting face and then pile it safely to one side.

The excavator did just that, removing unstable earth that, while it hadn't yet slipped onto the railway, could have done so at any time. A smaller excavator worked at the bottom of the cutting, removing debris there.

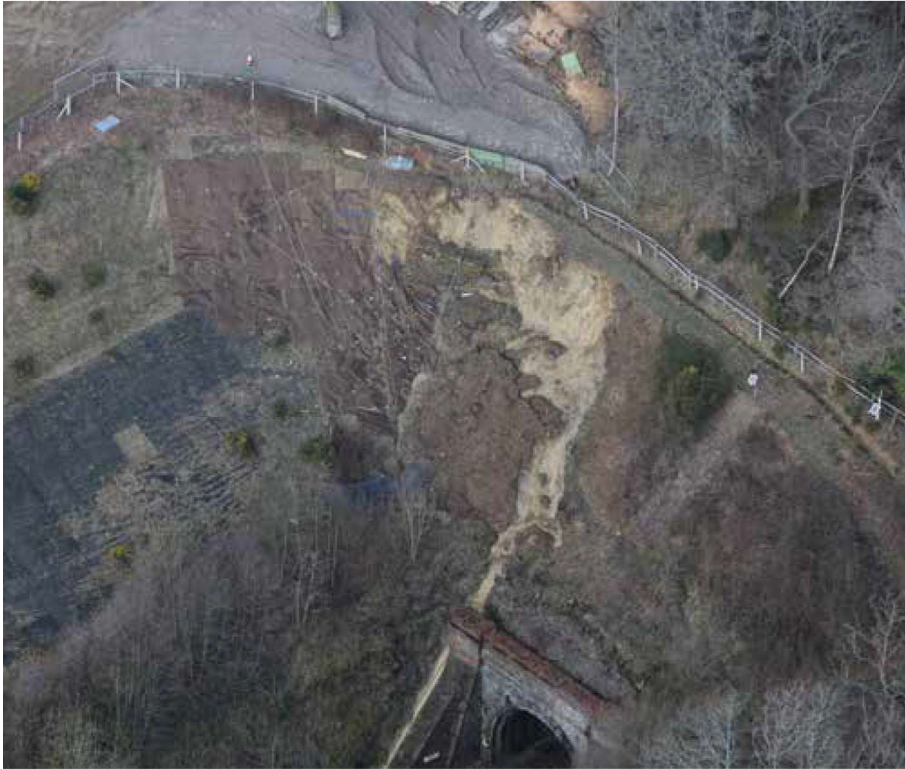
However, reports then came through from the team conducting aerial surveys of the cutting. A second slip had occurred, one kilometre further south, over the southern portal for Wadhurst tunnel (above).

Material had obviously moved, but hadn't fallen onto the track. It couldn't be left there as it could move again at any time. Another 60 tonnes had to be removed.

The heavy equipment at the first site was duly moved south and began pulling material away from the tunnel portal. This continued throughout the night and the railway was finally handed back at 04:45 on Monday morning, before the first train and in time for the rush hour, with a 20mph temporary speed restriction in place.

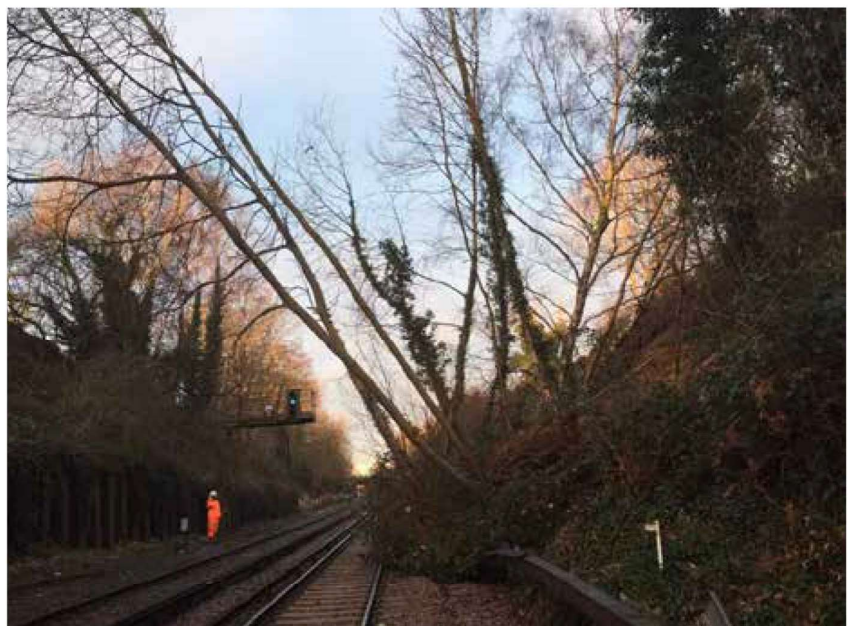
The landslide had caused a tree to fall on the tracks, blocking the line (below). The line was therefore closed and trains cancelled. This was the fourth time this cutting face had slipped since 2010, hence all of the monitoring arrangements.

After examination by engineers, the decision was taken to clear the site and then to make the cutting safe by using H piling - H-shaped steel beams driven into the ground with concrete panels between them to build a wall that will prevent slippage in the future.

300 tonnes of earth and trees were removed and then work could start on the 30 metres of wall. Piling was finished by Friday 15 February and the wall infill panels completed over the weekend.

Work was also undertaken to ensure the track was safe, replacing and replenishing contaminated ballast, and after test trains ran through on Sunday evening to check the repairs and test the signalling, the railway was ready to open on Monday 18 February, one week after the landslide had occurred.

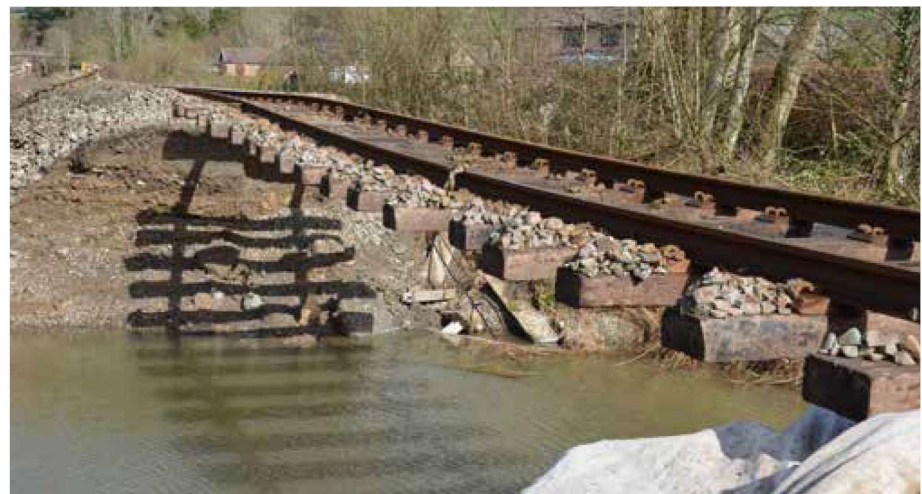
That's if the water doesn't wash the ballast away altogether, leaving tracks hanging in space and unsupported (pictured).

Which is just what happened recently on the Conwy Valley line in Wales. Following damage caused by Storm Gareth in March, the line, which runs between Llandudno Junction and Blaenau Ffestniog, will remain closed for a number of months.

Detailed inspections revealed that at least nine sections of track, as well as lineside equipment, embankments, bridges, level crossings and stations, would require significant repairs.
