# Montaña Suiza de Aranjuez – Slope Monitoring

CLIENT: ACRE / PATRIMONIO NACIONAL

How wireless monitoring was used to inform decision making and safeguard a vulnerable slope at UNESCO World Heritage Site in Madrid

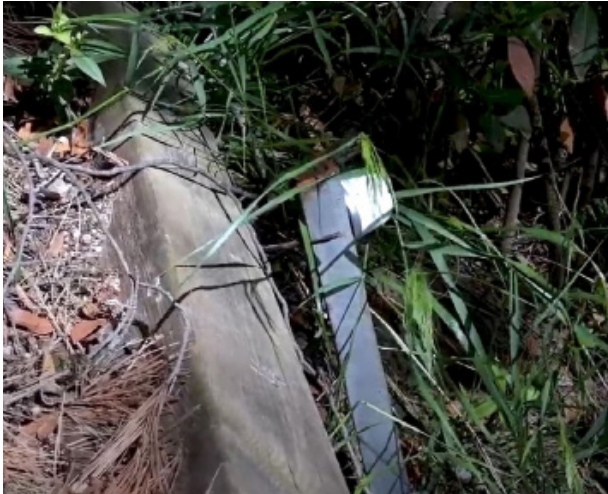
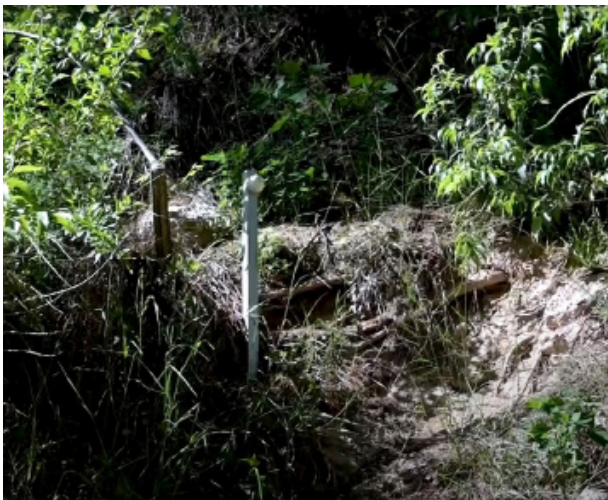
Once the area of the slope that needed to be monitored was defined, ACRE installed Nanos on six 1.5 metre stakes. The stakes were set out in two rows, one next to the fence where the damage had occurred, and the other at the bottom of the slope.
