Earthworks Monitoring: St Leonards

CLIENT: NETWORK RAIL/COSTAIN

How long-term wireless condition monitoring was installed rapidly on steep cutting slope to reduce risk of disruption and accidents.

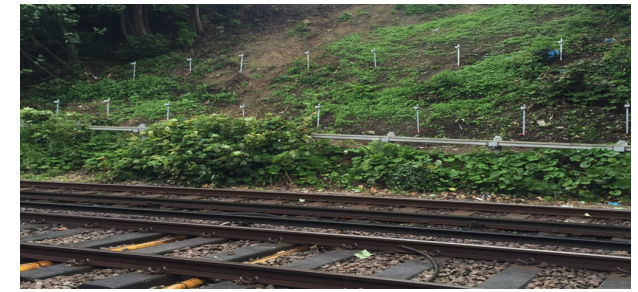
The robust and stable sensors were fixed to stakes embedded in the de-vegetated slope on a grid pattern. The system comprised a solar-powered 3G gateway and 20 wireless FlatMesh™ tilt nodes. Once the groundworks were complete, the nodes were deployed using stakes and customised mounting plates. The solar 3G gateway was then quickly and easily installed on a nearby post to transmit the data from the nodes to the WebMonitor software.

A solar-powered FlatMesh wireless camera was also installed to detect objects of football-sized and bigger encroaching on the track, day or night. As well as sending regular images of the track, this remotely configurable camera could be triggered to capture a picture in the event of a movement threshold being exceeded by any of the nodes.
