Bazergues - Emergency Dam Monitoring

CLIENT: SITES/VILLE DE COMMENTRY

How a rapid response monitoring solution helped protect infrastructure and local people

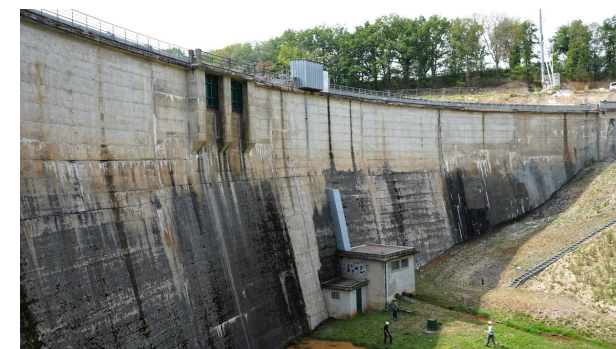
The FlatMesh™ gateway allowed the immediate and automatic connection of all sensors on site without any configuration. Data were transferred continuously via the local cellular communications network.

Within five days of their query, the Sites team had received its equipment for an immediate installation on site. The small enclosures and bespoke beam brackets enabled easy installation of the system within just three hours by a three-person team.

Dam rotation was monitored at a resolution of 0.0018mm/m at a 30 minute reporting rate without the risk of the sensors dropping out of range. All data were continuously sent to Sites visualisation platform Simon-e®.
